Restoration of Darche 1908 Flashlight Alarm

Ken Reindel
Ken's Clock Clinic

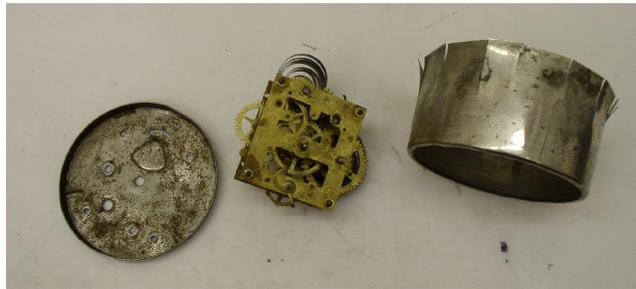
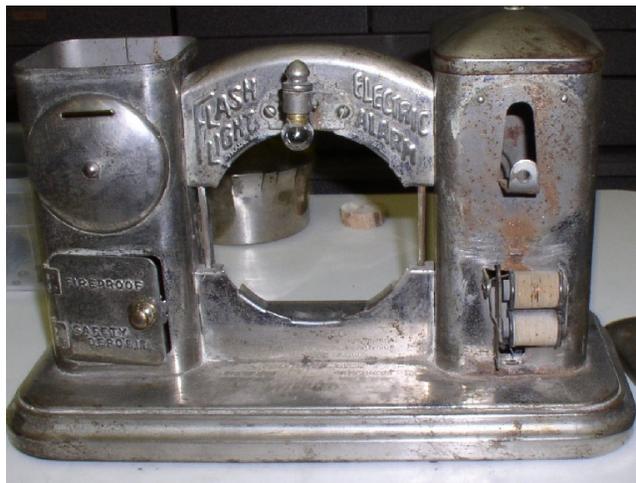
The subject clock for this restoration is shown above. In great disrepair with rust and corrosion throughout, the challenge was to bring it back to life.

Several enormous challenges with this clock are noted. First, the clock movement can be split all the way around its perimeter. It will have no part to play in a quality restoration and there is no

way to repair it. A new can would have to be fabricated. Second, not quite visible from the pictures, is the corrosion resulting from battery leakage over the years. There was not a single wire that could be reused due to corrosion, dry rot, or other problems.

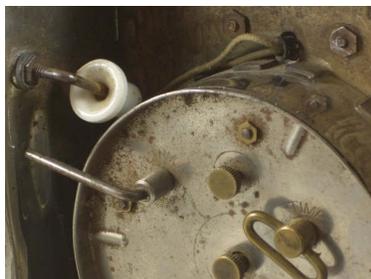
The basic idea behind the Darche Flashlight clock is fairly simple. The alarm key is replaced by a winding lever which, when the clock alarm activates, turns and causes contact with an electrically "hot" C shaped bar, closing the alarm circuit which activates the electric bell. See figure to the left. (We have Vince Angell to thank for this figure since our clock had no alarm winding lever present). The light on this particular clock was on a separate circuit and did not activate with the bell. A separate remote switch, tethered at the end of a cord, could be kept near the bed, under the pillow, etc. In the dark of night, the button could be pressed to illuminate the dial. The No. 6 battery was stored in the right-side "silo" can out of sight. Some of the Darches used two batteries, and these batteries mounted outboard behind the two cans. But this particular clock stored the battery internally.

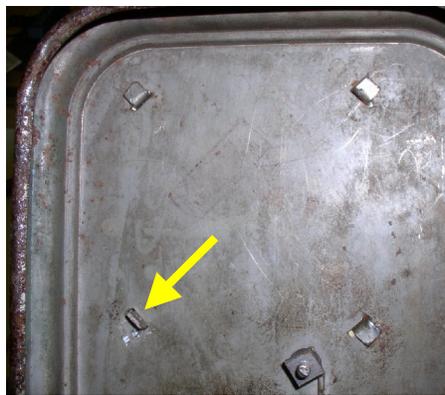
Disassembly. The task of disassembly began with difficulty. The .068" thick tabs securing the silos proved to be an enormous challenge. Sharpening a screwdriver to a wedge afforded a tool to pry them up. This was followed by straightening with pliers. These tabs did not bend easily (lower left). Would they survive bending back down to re-secure the silos, or would metal fatigue get the better of them? Hopefully they would survive, but we wouldn't know that until we were almost finished with reassembly.

A possible option for the tabs is to scribe a line where the tab meets the underside of the base, and then once disassembled drill holes in the tabs for taper pins just at the scribe lines. The advantage of this is it would allow as many disassemblies of the unit as desired. The tabs would

never need to be bent over again. Speaking now with hindsight, this is what I would do if I were to start over.

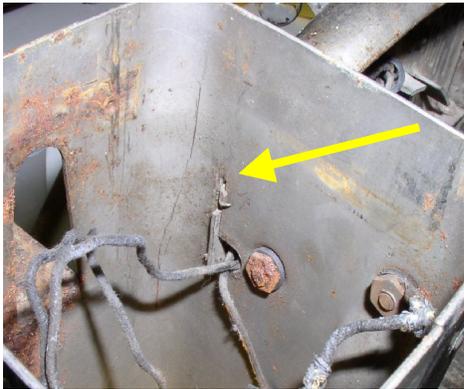
Another problem was the bent tabs inside both cans, utilizing the top cross member to pull the silos together. There is no way this would survive removal. I thought about drilling holes for a draw bar between the left and right silos. Ultimately I elected to forego the idea, since the clock was rigid enough and the silos properly aligned with no assistance. It could be an option if the silos had an outward tilt, as there is clearance behind the upper cross member to accommodate this.

After either drilling out or removing the rivets holding the base of the “bank” unit internal to the left silo, the door and all buzzer rivets and coil yokes, the unit was disassembled into its parts and the restoration could finally begin.

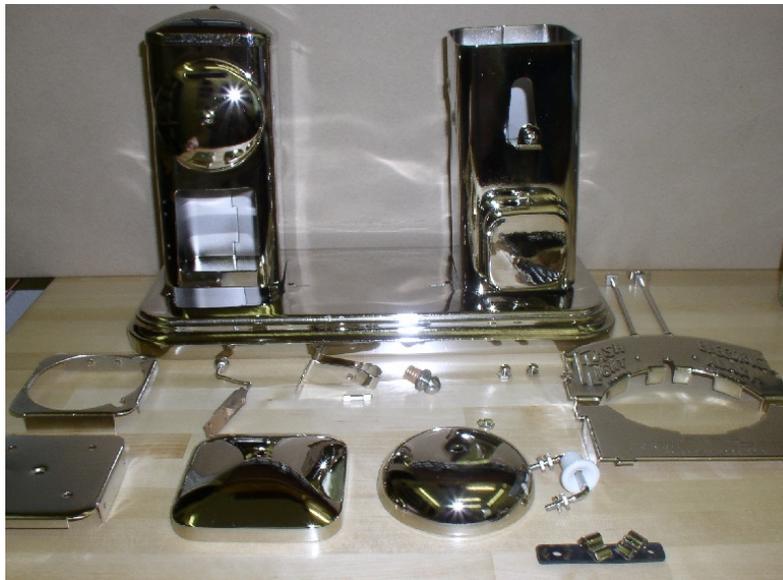
Some of the internal parts were badly corroded. In general, this is inconsequential as long as the corrosion is removed and none of it passes through the part. We were fortunate. All of the parts were reusable, despite clear evidence of battery leakage eating away at internal components. One hour in the nickel tank and the parts were ready to go. Every part, down to the last screw, nut, lug and gadget, was cleaned, pre-polished, and nickel plated. The nickel plating took two 14 hour sessions to complete, not including the clock can.

Shown below are the results of the first plating session. Another plating session completed the movement can, door and knob (which needed to be reconditioned on the lathe to restore the shape and knurl). The bank draw bar, nuts, screws, alarm winding lever, and some other small parts are likewise not shown but were likewise plated.

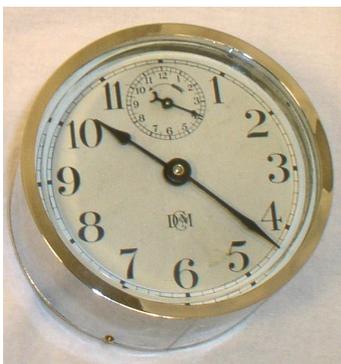
Clock Movement. Likewise the movement restoration was quite involved on this unit. The "Before" picture is shown to the right. It required a new alarm main wheel arbor, and alarm setter arbor as well. Both were sheared off and the parts missing. Again I will not go into a detailed explanation of what it took to engineer the missing parts. The thread required a 5-40 LH tap and die. The alarm setter arbor and knob required a 3-48 RH tap and die. Both the setter knob and arbor were fabricated at the same time. Getting the length and protrusion from the dial required substantial trial and error. The result is shown to the left. Clearance to the hour hand was critical. Another point about the movement: a stop pin needed to be added near the center wheel pinion. This pin was not in the original design. Without it, the mainspring would impinge on the center wheel, stopping the clock long before it was unwound.
