## **White Paper: Antique Alarm Clock Plating Restoration**

**Author: Ken Reindel, Ken's Clock Clinic**

**Date: May 17, 2003**

**Introduction.** In this White Paper we will consider several of the issues surrounding the restoration of metal antique alarm clock cases. The following topics will be covered:

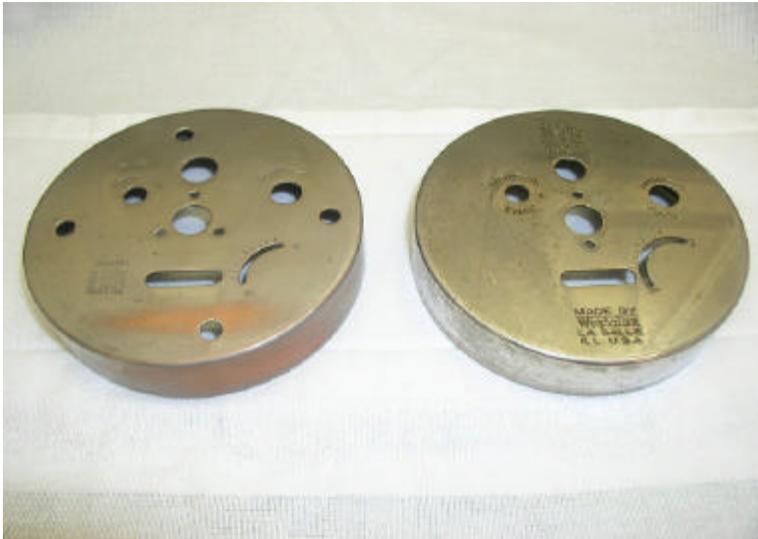
**Figure 1.** Here are some examples of early Westclox Style 1 (right) and 1a (left) rear bell covers removed from the clock. In general, it can be seen that the plated finish is past end of life.

Polishing fundamentally works by removing microscopically thin layers of plating. Eventually there just isn't any more nickel plate left to polish. In particular, previous polishings and cleanings have removed all of the nickel in a few spots (above left), exposing the copper beneath it. The rear bells above are steel as were most. When new, these bell covers were highly polished. To achieve this, the surface is polished *before* nickel plating. Steel is very expensive and difficult to polish, so the clockmakers would plate the steel first with copper, polish the copper (which, because it is softer, polishes beautifully), and then nickel plate the polished copper. The nickel applied to these clock cases was often too thin to withstand much polishing beyond an occasional touch-up.

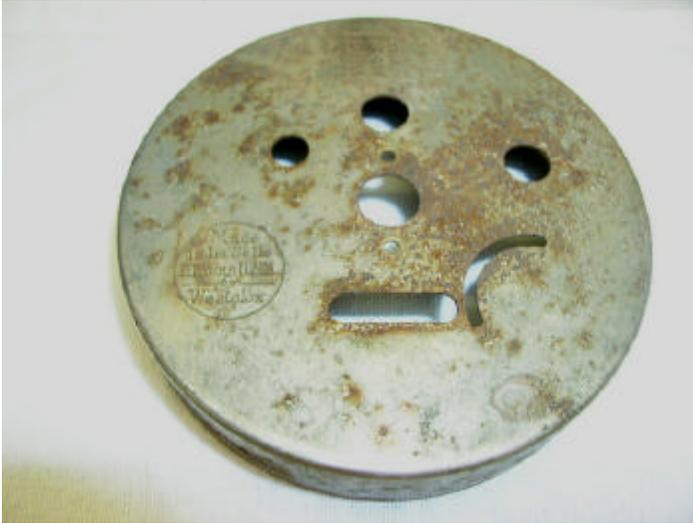
Another enemy of these early clocks was the environment, not the least of which is skin oil from regular handling. Skin oil is rich in acids, salts, and other organic and electrolytic compounds. Over the years, the thin layer of nickel is eaten away by these substances, leaving little left but the thin copper protecting the steel underneath. Once the corrosion starts, the plating is pushed off from underneath and more corrosion occurs. As a result, we will encounter very few antique alarm clocks with nickel plating in satisfactory condition. Usually we find them corroded, rusted, and pitted. Even the bezels are unsightly, the nickel worn away and the brass underneath tarnished and blackened. Below is an extreme case on an unfortunate Style 1 rear bell cover:

**Figure 2.** Badly rusted Westclox Style 1 Bell Cover

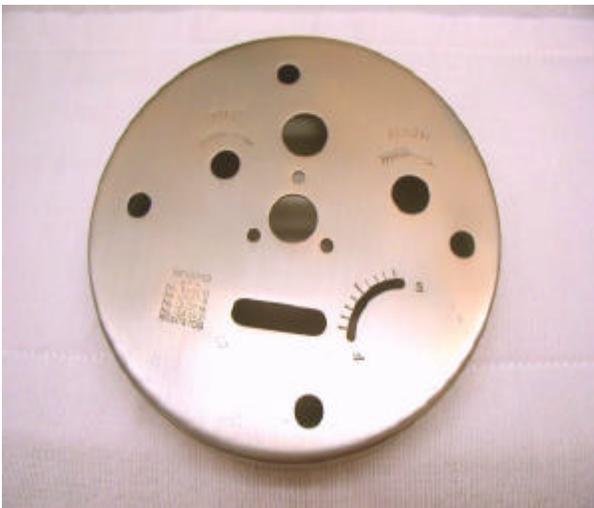
**Figure 3.** Here is a photograph of the above Style 1a (on the left) bell cover stripped of nickel. Note the slight haze of copper flash remaining (inconsequential), and also the cleaned out rust pits, ready to fill and restore.

Our process begins with a thorough deplating and cleaning of the parts. This is a critical step. Every trace of rust and corrosion must be removed on steel backs, bells, keys, etc. Also, the removal process is critical to preservation. We cannot use acid to strip parts. Rust pores often tunnel deep into the substrate. Acid, if trapped into these pores, will cause delamination of the plating later on. Therefore, many of our components are stripped with a dry process that leaves them beautifully clean. In some cases we use a special formulation designed to selectively remove nickel, while leaving even the copper flash untouched. See illustrations below.

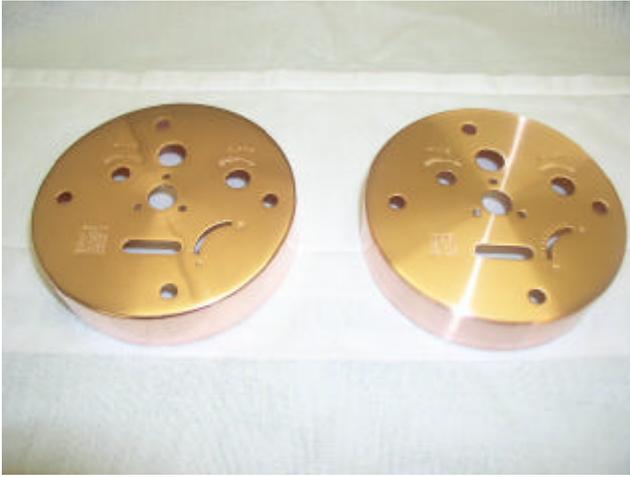
**Figure 4.** Here are examples of two rear bell covers after filling, copper plating, and graining, ready for polishing and nickel plating. All pits, scratches, etc. have been repaired at this point.

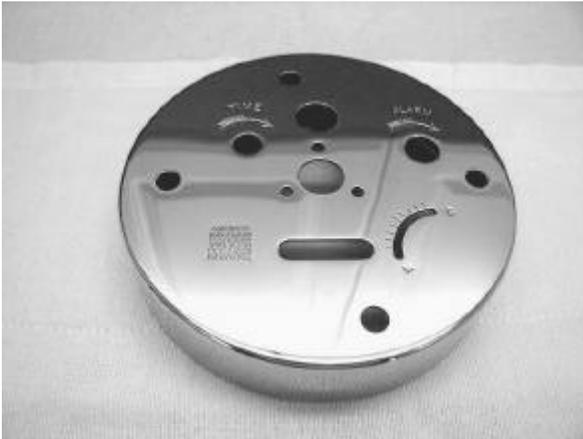
**Figure 5.** The final result, after polishing and nickel electroplating, is shown to the left, ready to reinstall on a beautifully restored clock.

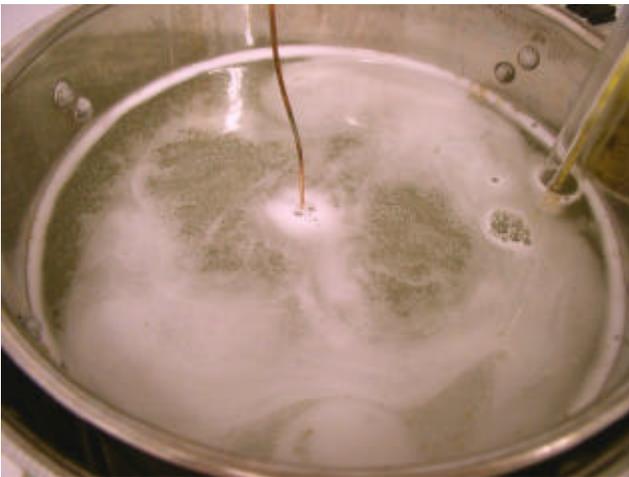
**Figure 6. Our Electrocleaning process:** We immerse the part to be plated into a specially formulated mildly alkaline conductive cleaner. An electric current is applied, which activates the surface at the atomic level much as the plating process will. This assures smooth plating, free from voids and pits.

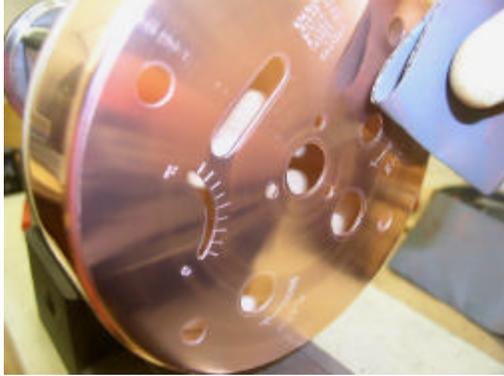
**Figure 7. Flattening and Graining.** Parts are grained on a fixture in the lathe to assure that final buffing provides the same color, depth, and pattern of the original finish. This is a critical step in controlling polishing/buffing marks and improving appearance under strong lighting conditions, as might be found in a show case.

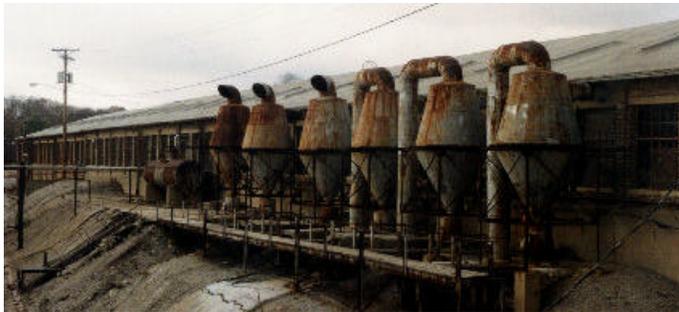
**Figure 8.** No, this isn't our factory! These are the dust collectors used in the original Buffing Dept. in the Westclox plants of the early 1900's. We don't have quite this many collectors, but it's a good illustration of early efforts to keep working conditions clean for clock case finishers.

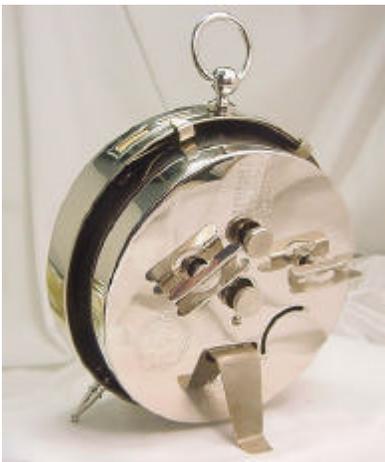
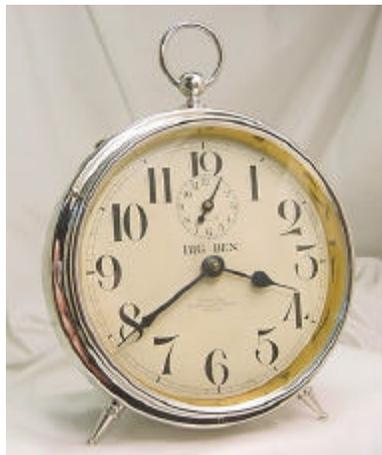
**Figure 9.** One of our fully restored Style 1 Big Bens. What a difference the new nickel plating makes to this 90 year old beauty!

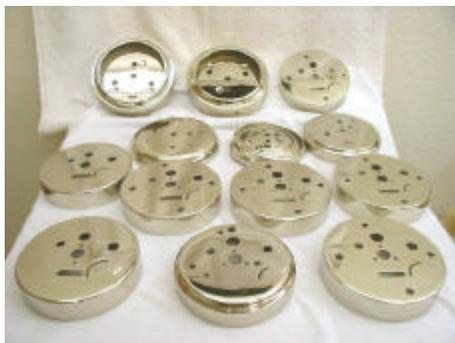
**Figure 10.** More fully restored articles awaiting shipment or reassembly into clocks
