Restoration Projects: Miniature Ansonias and Waterburys

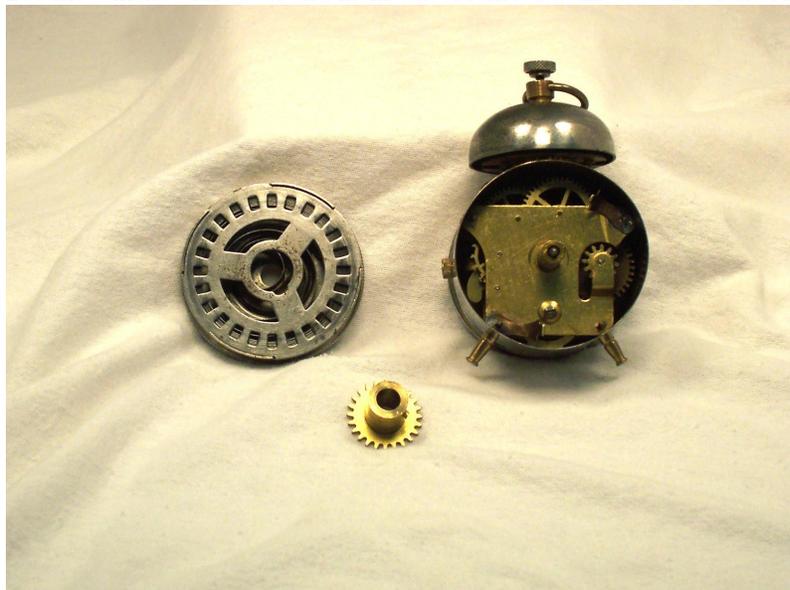
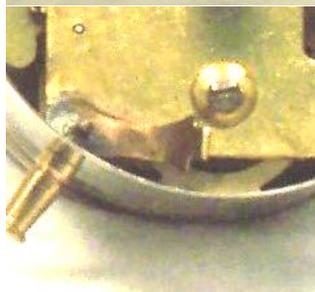
Figure 1: At the left is the rear cover of the clock (acting as a mainspring barrel and ratchet wheel). In the center is the main wheel (driven by the mainspring in the barrel shown at the left). At the right, the Ansonia Bee movement with cover and main wheel removed. Inset: One of the Ansonia Bee clicks

The "click" is a pair of flimsy brass tabs protruding from the pillars of the movement as shown in the inset. We have only seen one original undamaged click out of the many clocks we've examined. Usually they have been soldered onto the pillars (as is shown here) because the original staking had come loose or the click had broken off at the base. Most of the

time, one or both of the clicks are missing and replacements must be fabricated. It's best to fabricate replacements from strips of spring steel (brass does not hold up), then fasten them back to the posts with taper pins inserted into a 0.020" hole drilled into the pillar tab. Solder must be avoided. Blobs of solder are unsightly and flux from the solder can cause irreparable corrosion and damage to the rest of the clock.

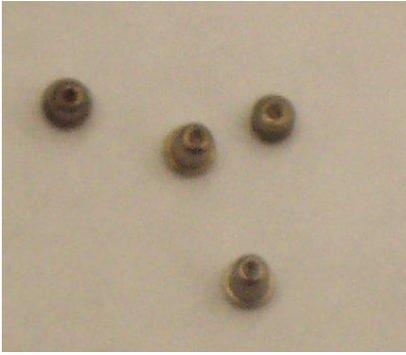
A frequently neglected repair is the balance pivot/balance cup. When balance pivots are worn, they usually wear the cups as well. It is very difficult to examine the cups even under highest magnification because of the inward conical shape. Light reflects off the surface and obscures the wear, which is near the apex of the cup. With 100 years of use,

it's almost certain these cups will need to be refitted. And, most certainly the balance staffs will need to be turned on a lathe and resharpened. Neglecting this repair will result in erratic timekeeping or even a clock that will not run for more than a few hours.

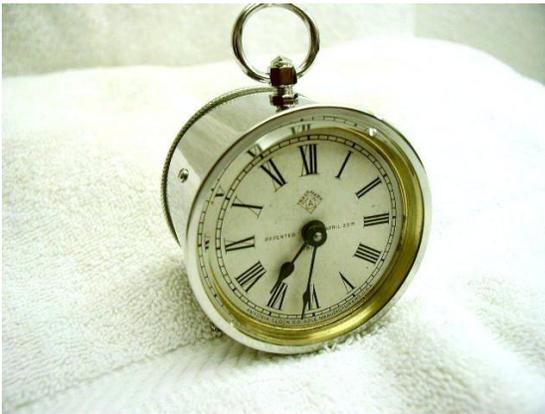
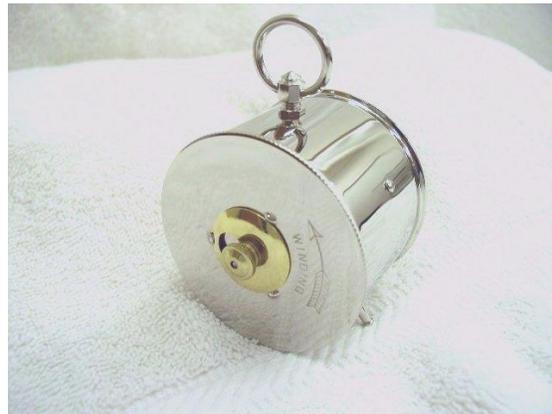
Once the movement work is done, attention is turned to the case work. Just as the movement requires special care, so it goes for the case as well. Handling these clocks over 100 years has the effect of wearing the nickel plating away. Skin oils and acids then attack the brass and sometimes leave deep pits. To repair these cases, all of the darkened nickel must be removed and the brass resurfaced. We use an environmentally safe product from MetalX to remove the nickel. To repair the pits, multiple layers of copper are plated over the brass, sanding between layers and ultimately buffing the copper to bring back the luster. Thereafter, nickel is plated over and a coat of metal wax applied. The finished product is shown in the following pictures, fully functional and ready to brave another 100 years of service ☺ :

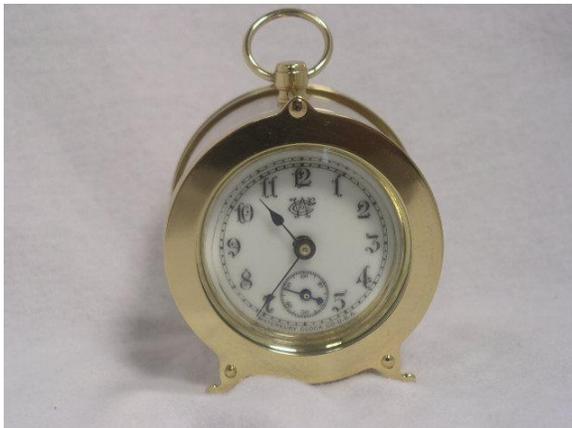
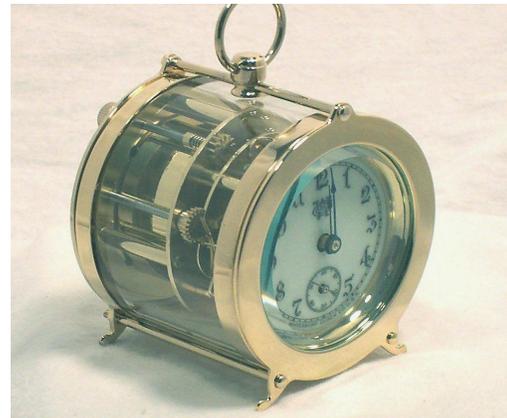
Bogie and Era which utilize the same movement as the Spider and Fang. This 8-day movement was used in a number of Waterbury novelty clocks of the era. Both the Spider and Wasp were gold-plated with a glass sleeve, and the movement can be seen through the glass. The Fang is the same clock as the Spider, but without the see-through case. All are fitted with a beautiful beveled lens and enameled dial. Generally, these clocks have been referred to me as Hornets and obviously there is some understandable confusion over identification of the different but very similar models. Adding to the confusion is that the Hornet and Fang are listed as having jeweled movements. I've not personally encountered any jeweled Spider or Fang movements as of this writing. Shown here are two Spiders that were subject of recent restorations.

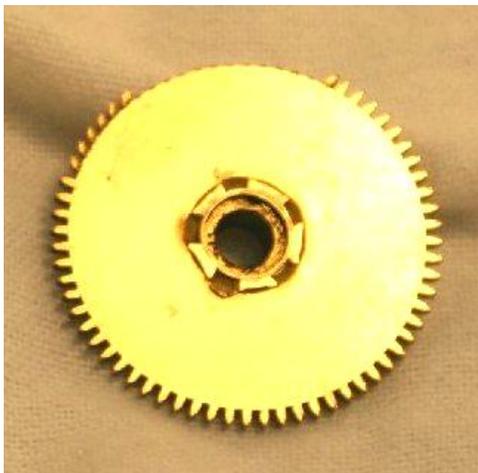
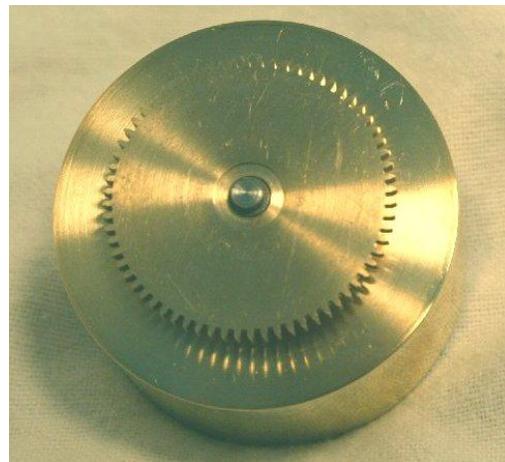
Real trouble starts when an 8-day mainspring fractures. The mass of the spring, the inertia in the uncoiling, and the fragility of everything around it add up to disaster. Shown below is an example of the main wheel from the Waterbury pictured above right, victimized by a broken mainspring. The "kick back" created by the uncoiling mainspring crashing into the sides of the barrel damages not only the main wheel, but also bulges the thin barrel at the hook which causes interference with the movement pillars. In extreme circumstances, this force can distort the barrel to the point where the lid no longer fits securely. We've seen third wheel pinion leaves bent by this force as well.

Left: Waterbury main wheel damaged by the sudden uncoiling of a fractured mainspring. Right: New main wheel attached to reconditioned barrel.

After spending hours reconditioning a barrel, it is important to exercise extreme care with the replacement mainspring (fortunately these are available!). We wind and unwind the spring on a winder at least 10x to identify potentially defective springs that might fail

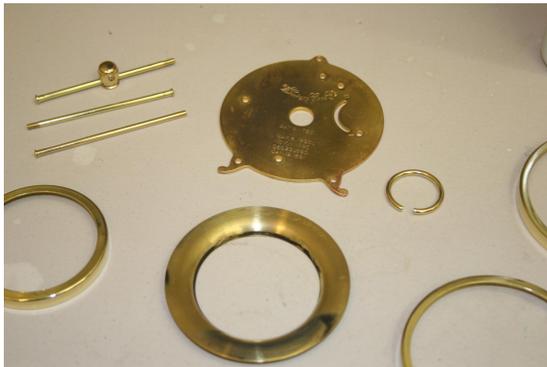
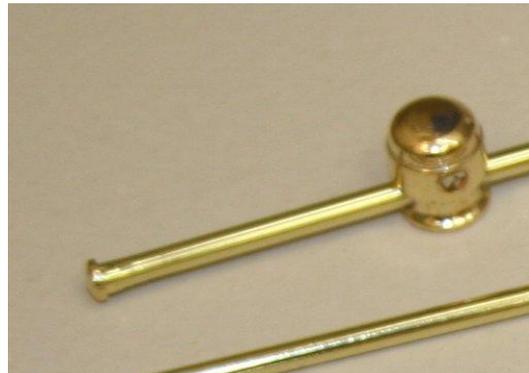
Restoring a Waterbury Case. The case on a Waterbury Spider is made up of a complicated sandwich of brass rings, collets, plates, and bolts, and a glass sleeve. Some of these components are shown below. Shown at the right is the “holy grail” of how to

disassemble the case. The top bolt was manufactured with the bolt staked to the center ring assembly, after the bolt had been passed through the upper hole in the front bezel. The result is an assembly that cannot be taken apart which makes it impossible to restore correctly. We've found the best technique is to grind off the front dimple. Afterwards, the bolt is chucked in the lathe, trued and center drilled, then tapped with a small tap such as a 1-72 or possibly a 2-56. A new “dimple” is fabricated with a threaded tail much like a screw but with no slot in the head, shown here assembled for polishing. This allows reassembly later, after all the parts have been restored. The resulting repair is invisible.

After filling pits in the case parts with copper, each part is either tumbled or machine buffed to luster (depending on the size and delicate nature of the part). A nickel flash is applied, immediately followed by a heavy 18 karat gold brush plate. There simply isn't anything like the finish of gold plating on a Waterbury Spider. It is difficult to avoid the gold if significant pitting has to be filled with copper, although we have seen some nice restorations done by polishing and lacquering the brass base metal (if it is in good condition) instead of gold plating. However, it just isn't quite as nice as the gold.

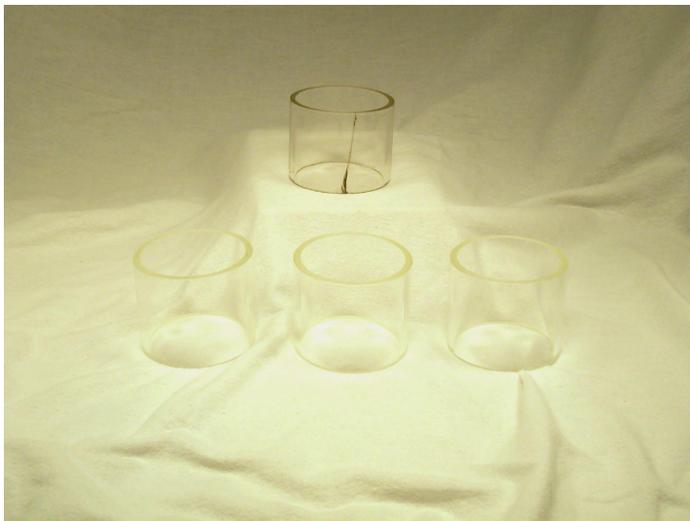
Shown below is a broken Waterbury glass sleeve, and the cut replacements in the foreground. Unfortunately, we haven't found a source for glass with air bubbles and ripples as was the case with the vintage glass. ☺ Simax glass is literally a laboratory grade, crystal clear, flawlessly beautiful product.

Glass Sleeves. Shown in the foreground are three cut sections of glass sleeve to be used as Spider cases. The diameter of these sleeves is about 1mm smaller than the original sleeve, which is not noticeable once installed in the clock. This standard Simax product, cut to size, makes a nice replacement for broken or missing Spider glass cases. An original broken Spider case is shown in the back.

Of all the heartbreaks encountered with the glass-cased Waterburys, nothing is more disappointing than a broken glass sleeve. Although no one to our knowledge sells replacements for these sleeves, there is a way out. Simax borosilicate glass tubing can be purchased in the broadest selection of shapes and sizes from Friedrich and Dimmock in New Jersey. See their website at www.fdglass.com/store. They were willing to cut a 5ft section of tubing to the size we needed, but there was a \$150 minimum sale charge. The other difficulty was that we needed to grind the ends of the sleeves to square and parallel. Presumably it's difficult to expect a glass cutter to hold tolerances needed in clockmaking.
