Restoration of Darche 1908 Flashlight Alarm

Ken Reindel
Ken's Clock Clinic

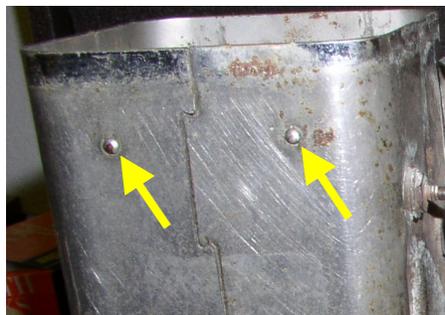
The case itself is built like a tank. It is constructed of very heavy gauge, .068" thick cold rolled steel which has been stamped, bent, formed and dovetail joined (quite the contrast to the .015" thin drawn brass can housing the movement). Tabs coming through the base are bent over to secure the silos. The clock movement can is cleverly held in place by draw bars (visible in the picture above) that are tightened by nuts on the bottom to sandwich the clock between the two semicircular cross members acting as clamps.

As received, the front door combination lock was jammed shut. The internal mechanism would not turn with the knob so there was no way to get the door opened! This would not prove to be a big problem for me since the door rivets would have to be drilled out and removed anyhow, but could be a daunting challenge for a new owner if this was not the case. The silo had internal panels that were likewise riveted in place. These would have to be removed for restoration so that all corrosion and repair could be carried out. The buzzer coils, contacts, armature, etc. were also riveted in place and would need to be ground away for removal, drilled and tapped for replacement.
