Bench Notes: Self Winding Clock Co. No. 37-SS

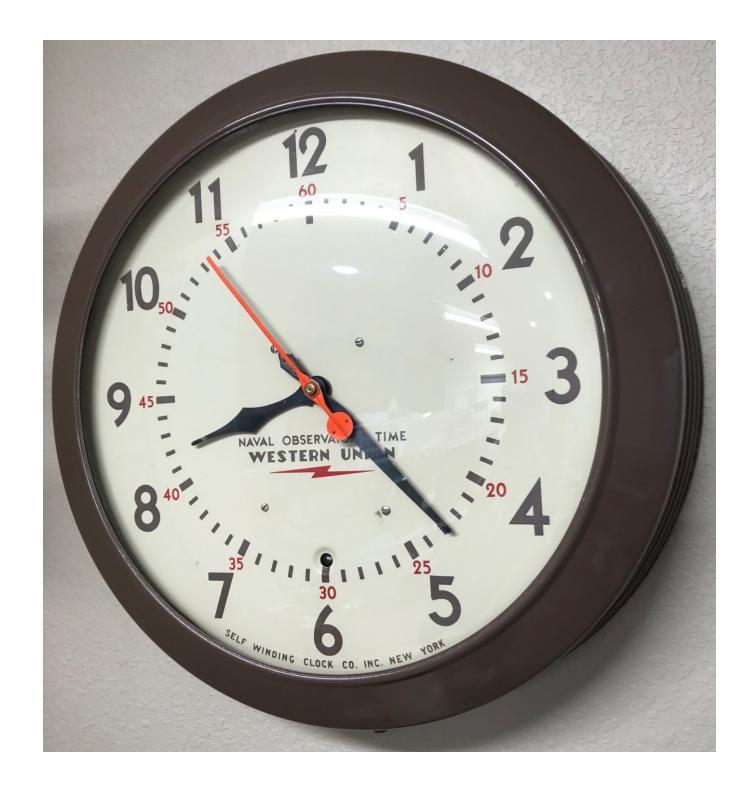
There are several interesting "bench facts" about this rather collectable self-winding clock which are worth clarifying. Below is a picture of a typical No. 37-SS, this one in quite good condition.

The 37-SS is considered the Broadcast Studio model, "SS" presumably for Sweep Second. The very visible red hand was required by folks in the broadcast industry who wished to synchronize broadcast events and needed to be able to see the second hand from a distance. Rough guess is that this model first emerged somewhere in the late 1930s or so. We have seen some early examples built in the No. 29 style wooden cases, but most are found in brown formed sheet steel cases.

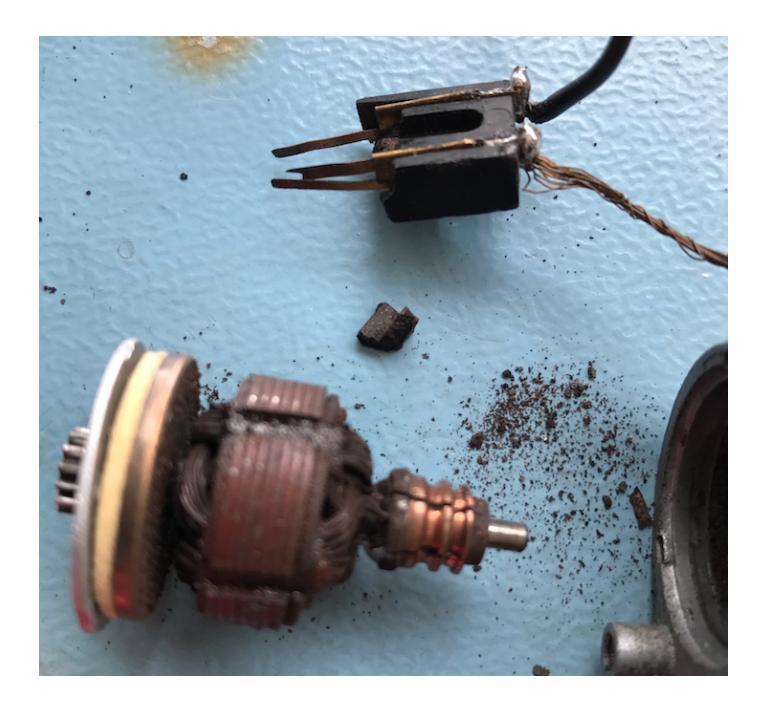
Clocks equipped with this die cast German motor will wind in about 2 seconds or less, once per hour. Disappointedly, these motors were prone to contact and commutator failure (due to the fragile components coupled with extremely high surge currents needed to start them). See picture below. This was a die cast motor as found, disassembled to show the self-destruction which occurs inside this motor. They are often found with dead spots, which prevents normal, reliable winding. These motors present an unusual repair and restoration challenge, but we have developed methods for accomplishing it.

German Die-Cast Motor. Our observation is that many modern movements (late 50s forward) used a German-manufactured die-cast motor to replace the vibrating armature motor (with the large coils) used from the late 1890s through 1960s. Many of these have FR prefix in the serial number, although some FR prefix serial number movements do not have this motor.

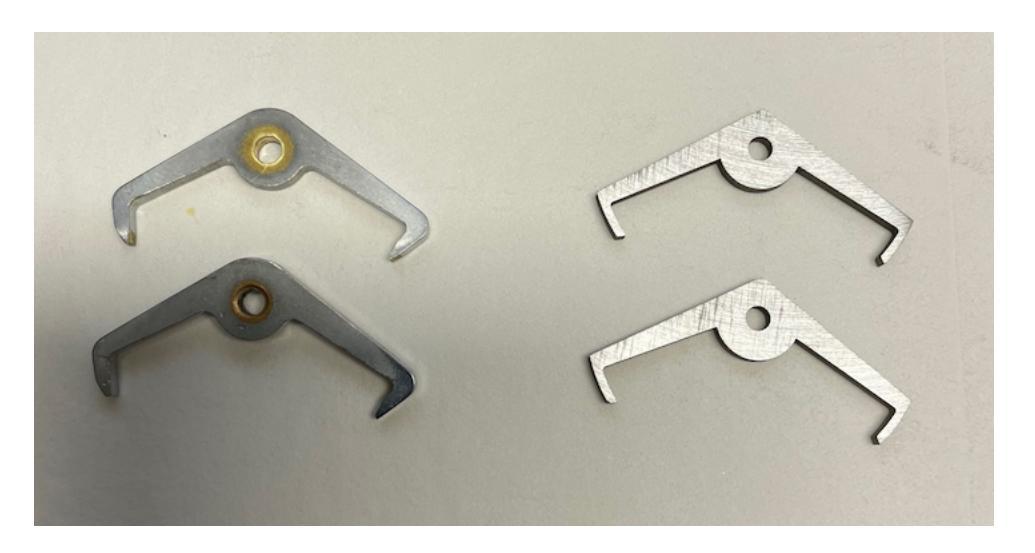
Below and on the left are examples of the hard chrome-plated brass verges. On the right are examples of hard tool steel verges, unfinished.

Escapement Verge. Another interesting item in the 37-SS is the escapement verge. For over 5 decades, these verges were fabricated from tool steel and heat-treated pallets for hardness. These tool steel verges were quite robust. Many we find

are still restorable although periodically we need to replace them as well. Most SWCC 37-SS were equipped with a brass verge with hard chrome plate. While it did reduce cost of manufacture, these verges rapidly wear through the chrome and leave the soft brass exposed. This creates serious friction and pitting which decreases reliability of the clock. We believe the verges may have lasted 10 years at best, vs. many decades with the original tool steel designs. The original tool steel verges could often be reconditioned and adjusted, but not the hard chrome plated versions. Of course, dusty or dirty environments accelerate wear.

We have seen numerous brass verges used in the 37-SS with serial numbers ranging from the early 300,000 range to over 400,000.
